Simple Structural Modification Solves Vibration Problem

State-of-the-Art Vibration Analysis Techniques

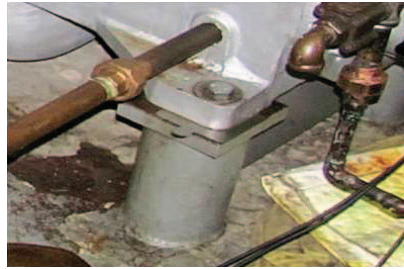
Before

foundation structural dynamics. Logging equipment was installed to map a spectrogram of the pump-motor vibration characteristics. Employing state-of-the-art vibration analysis techniques, Flowserve technicians analyzed operating deflection shapes (ODS) to impact deflection shapes (IDS) through model analysis and identified a structural natural frequency at the operating speed. It was determined that the BFP had excessively high vibration in the pump's inboard and outboard horizontal planes: a Pump-Outboard Horizontal (POH) 1x horizontal velocity of 0.342 in/sec RMS and only slightly less severe in Pump-Inboard Horizontal (PIH).
