Simple Structural Modification Solves Vibration Problem

State-of-the-Art Vibration Analysis Techniques

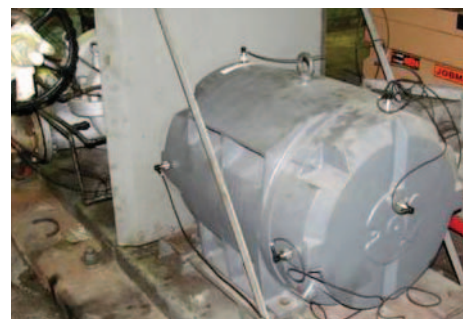
foundation structural dynamics. Logging equipment was installed to map a spectrogram of the pump-motor vibration characteristics. Employing state-of-the-art vibration analysis techniques, Flowserve technicians analyzed operating deflection shapes (ODS) to impact deflection shapes (IDS) through model analysis and identified a structural natural frequency at the operating speed. It was determined that the BFP had excessively high vibration in the pump's inboard and outboard horizontal planes: a Pump-Outboard Horizontal (POH) 1x horizontal velocity of 0.342 in/sec RMS and only slightly less severe in Pump-Inboard Horizontal (PIH).

Based upon the ODS and IDS findings, Flowserve technicians recommended the addition of gussets to fortify the pump baseplate. This simple, low cost fabrication solution increased the structural natural frequency by more than 50 percent and eliminated the high vibration. The POH 1x horizontal velocity was reduced to 0.050 in/sec RMS or less; the PIH 1x horizontal velocity was similarly affected. Safety and reliability concerns due to premature seal and bearing failures were satisfactorily addressed.
